June 2009 SAFECOM Summary

FOREST SERVICE AVIATION RISK MANAGEMENT

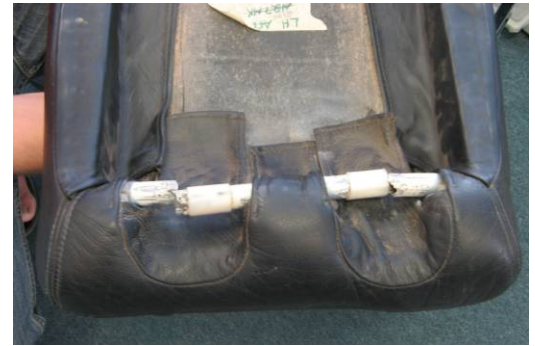
09-0307 - On 6/14/09 at approximately 1645, while performing ground training with cargo letdown out of the 407, I observed the left rear seat bottom cushion had pivoted slightly after a few repetitions. After looking under the seat where the safety wire was attached, I noticed the aluminum rod that attaches the seat in place was completely separated in 2 places on both ends of the rod, which were aligned with 2 small holes in the rod. **CORRECTIVE ACTION:** The pilot was notified and the seat was immediately replaced along with the safety wire. Pilot called company to inform them of the repair and replacement of seat cushion. Pilot put entry in maintenance log. Aircraft Maintenance Inspector, was notified, he advised of SAFECOM entry, Photo documentation and logbook entry. The Washington Office West {WO West} was notified of this problem. Additional notifications were made to R6 Rappel bases with Bell 407's. The WO West sent out the photos and a note to all regions. See previous Safety Alert No. FS-SA 08-06 6/6/08 Subject: Bell 407 Seats. RASM Comment: This event was handled very professionally by this Rappel Crew! The corrective actions were well executed and immediate. The Region 6 Maintenance Staff coordinated with WO West throughout this process to ensure we could safely continue to operate this aircraft in a Rappel mission. Notification of this event was effectively sent to all Regions. Job well done!
